**Bunker Hill Mine Flood-Stanly
Ore Body In-Mine
Reconnaissance Report**

**Bunker Hill Mine Water
Presumptive Remedy**

Prepared for
**U.S. Environmental Protection Agency
Region 10**

Bunker Hill Mine Flood-Stanly Ore Body In-Mine Reconnaissance Report (Supplement 2 to the Presumptive Remedy Conceptual Model)

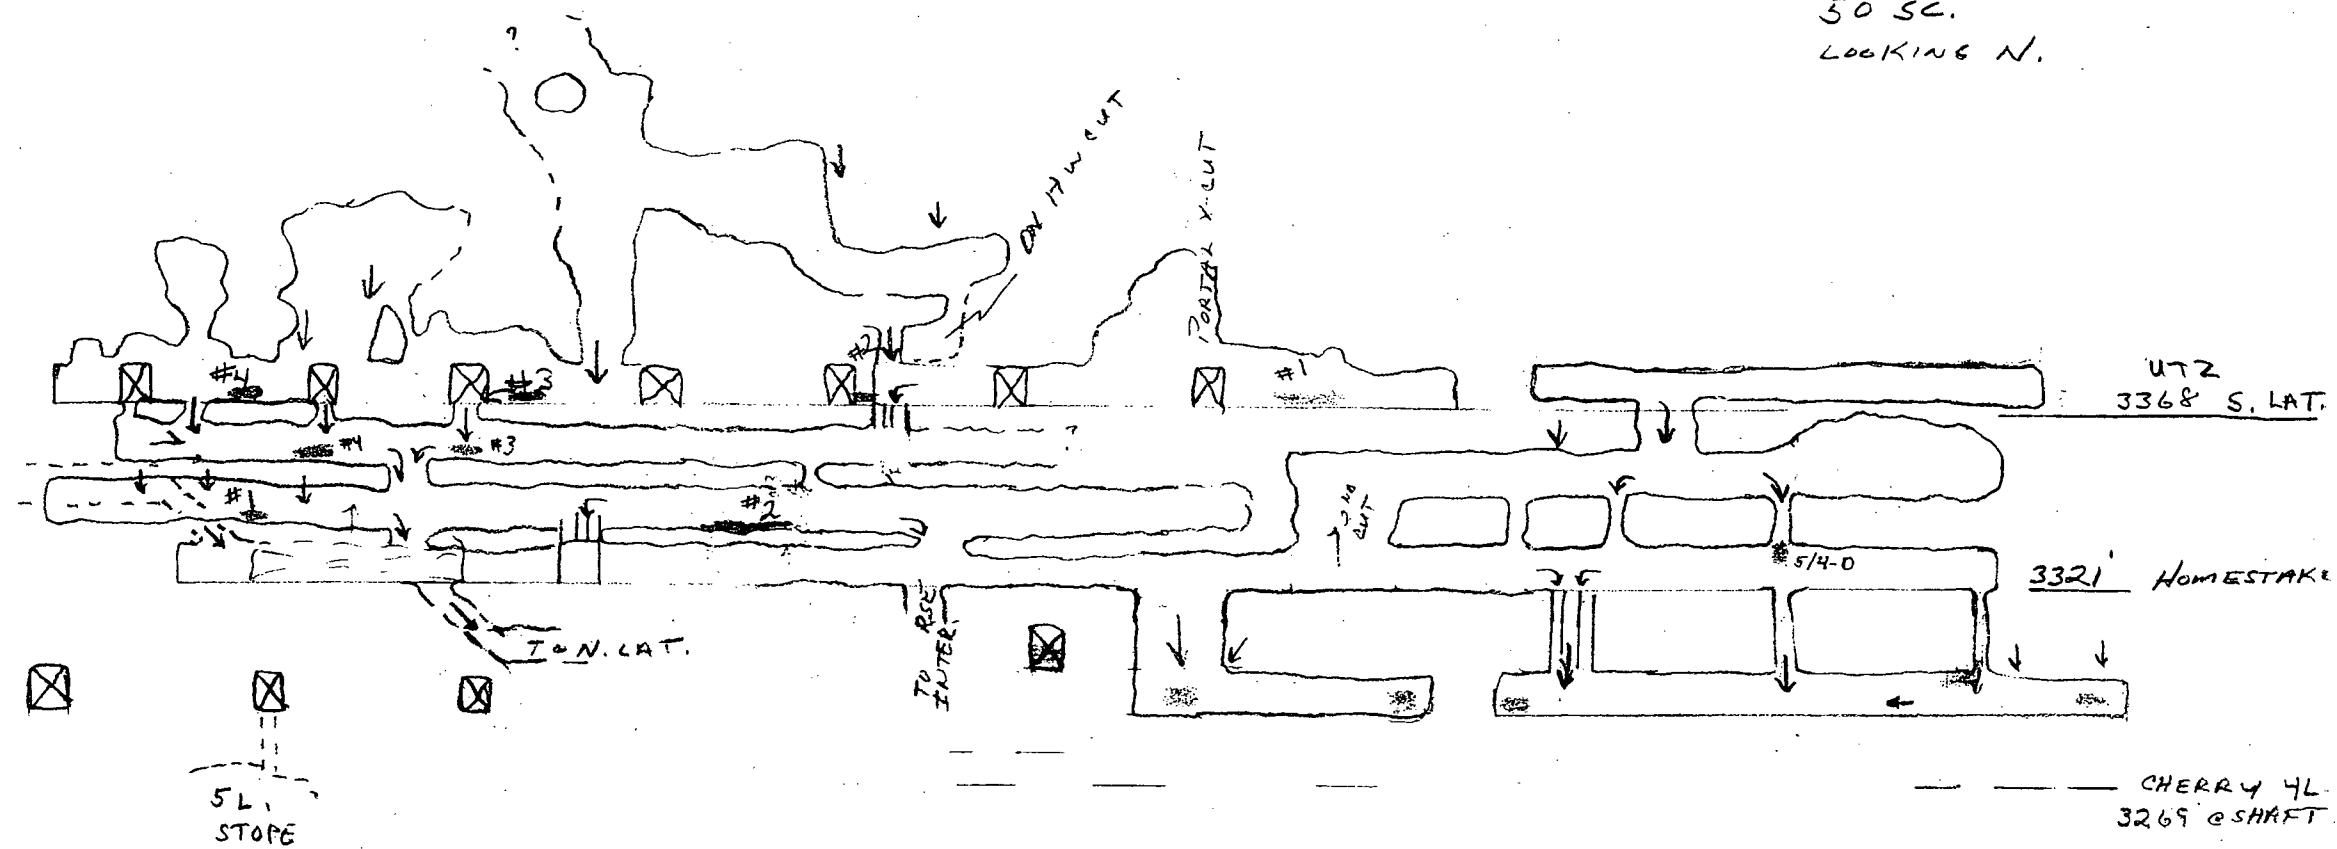
FIGURE 6

Discharge from Cherry 4 consists of drainage through transfers and collapsed ground, and into stopes. The water flows generally to the western parts of 5 Level in the vicinity of the underground greenhouse. Cross sections of the Utz, Homestake, and Cherry 4 are presented in Figures 6 and 7. Please refer to Figures 1, 2, and 4 for the cross section locations.

CROSS SECTION A-A'
(REFER TO FIGURES 1,2,4)
SCALE: 1" = 50'
